## The Therac 25

A case study in safety failure

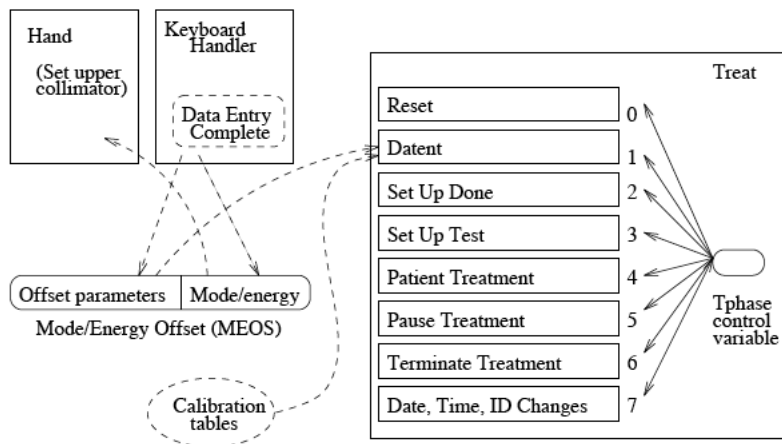
Figure 3: Tasks and subroutines in the code blamed for the Tyler accidents.

The keyboard handler parses the mode and energy level specified by the operator and places an encoded result in another shared variable, the 2-byte Mode/Energy Offset variable (MEOS). The low-order byte of this variable is used by another task (Hand) to set the collimator/turntable to the proper position for the selected mode and energy. The high-order byte of the MEOS variable is used by Datent to set several operating parameters.

Initially, the data-entry process forces the operator to enter the mode and energy except when the photon mode is selected, in which case the energy defaults to 25 MeV. The operator can later edit the mode and energy separately. If the keyboard handler sets the Data Entry Complete flag before the operator changes the data in MEOS, Datent will not detect the changes because it has already exited and will not be reentered again. The upper collimator (turntable), on the other hand, is set to the position dictated by the low-order byte of MEOS by another concurrently running task (Hand) and can therefore be inconsistent with the parameters set in accordance with the information in the high-order byte. The software appears to contain no checks to detect such an incompatibility.

Recall that the Tyler error occurred when the operator made an entry indicating the mode and energy, went to the command line, then moved the cursor up to change the mode or energy and returned to the command line all within eight seconds. Because the magnet setting takes about eight seconds and Magnet does not recognize edits after the first execution of Ptime, the editing had been completed by the return to Datent, which never detected that it had occurred. Part of the problem was fixed after the accident by clearing the bending magnet variable at the end of Magnet (after *all* the magnets have been set) instead of at the end of Ptime.

But this is not the only problem. Upon exit from the Magnet subroutine, the data entry subroutine (Datent) checks the Data Entry Complete variable. If it indicates that data entry is complete, Datent sets Tphase to 3 and Datent is not entered again. If it is not set, Datent leaves Tphase unchanged, which means it will eventually be rescheduled. But the Data Entry Complete variable only indicates that the cursor has been down to the command line, not that it is still there. A potential race condition is set up. To fix this, AECL introduced another shared variable controlled by the keyboard handler task that indicates the cursor is not positioned on the command line. If this variable is set, then prescription entry is still in progress and the value of Tphase is left unchanged.

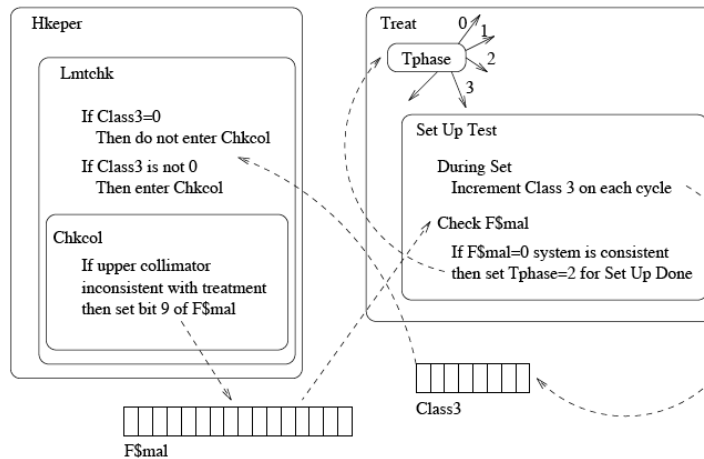
Figure 4: The Yakima software flaw.

During machine setup, Set-Up Test will be executed several hundred times since it reschedules itself waiting for other events to occur. In the code, the Class3 variable is incremented by one in each pass through Set-Up Test. Since the Class3 variable is 1 byte, it can only contain a maximum value of 255 decimal. Thus, on every 256th pass through the Set-Up Test code, the variable overflows and has a zero value. That means that on every 256th pass through Set-Up Test, the upper collimator will not be checked and an upper collimator fault will not be detected.

The overexposure occurred when the operator hit the "set" button at the precise moment that Class3 rolled over to zero. Thus Chkcol was not executed, and F\$mal was not set to indicate the upper collimator was still in field-light position. The software turned on the full 25 MeV without the target in place and without scanning. A highly concentrated electron beam resulted, which was scattered and deflected by the stainless steel mirror that was in the path.
