The Therac 25

A case study in safety failure

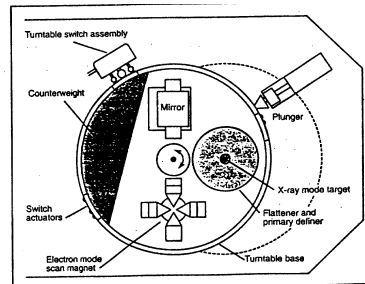
Figure B. Upper turntable assembly.

- Computer adjusts turntable position
- Microswitches detect turntable setting
- 3-bit binary code used to encode turntable setting
- Software checks replace hardware interlocks

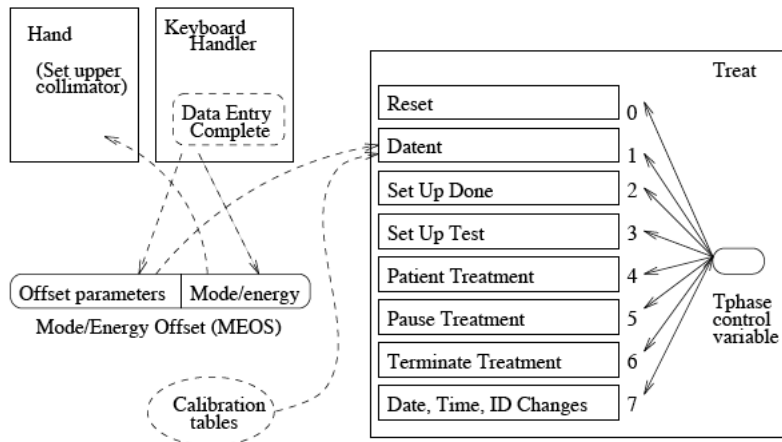
Figure 3: Tasks and subroutines in the code blamed for the Tyler accidents.

Race Condition

The keyboard handler parses the mode and energy level specified by the operator and places an encoded result in another shared variable, the 2-byte Mode/Energy Offset variable (MEOS). The low-order byte of this variable is used by another task (Hand) to set the collimator/turntable to the proper position for the selected mode and energy. The high-order byte of the MEOS variable is used by Datent to set several operating parameters.

Initially, the data-entry process forces the operator to enter the mode and energy except when the photon mode is selected, in which case the energy defaults to 25 MeV. The operator can later edit the mode and energy separately. If the keyboard handler sets the Data Entry Complete flag before the operator changes the data in MEOS, Datent will not detect the changes because it has already exited and will not be reentered again. The upper collimator (turntable), on the other hand, is set to the position dictated by the low-order byte of MEOS by another concurrently running task (Hand) and can therefore be inconsistent with the parameters set in accordance with the information in the high-order byte. The software appears to contain no checks to detect such an incompatibility.

Recall that the Tyler error occurred when the operator made an entry indicating the mode and energy, went to the command line, then moved the cursor up to change the mode or energy and returned to the command line all within eight seconds. Because the magnet setting takes about eight seconds and Magnet does not recognize edits after the first execution of Ptime, the editing had been completed by the return to Datent, which never detected that it had occurred. Part of the problem was fixed after the accident by clearing the bending magnet variable at the end of Magnet (after *all* the magnets have been set) instead of at the end of Ptime.

But this is not the only problem. Upon exit from the Magnet subroutine, the data entry subroutine (Datent) checks the Data Entry Complete variable. If it indicates that data entry is complete, Datent sets Tphase to 3 and Datent is not entered again. If it is not set, Datent leaves Tphase unchanged, which means it will eventually be rescheduled. But the Data Entry Complete variable only indicates that the cursor has been down to the command line, not that it is still there. A potential race condition is set up. To fix this, AECL introduced another shared variable controlled by the keyboard handler task that indicates the cursor is not positioned on the command line. If this variable is set, then prescription entry is still in progress and the value of Tphase is left unchanged.

Effective immediately, and until further notice, the key used for moving the cursor back through the prescription sequence (i.e., cursor "UP" inscribed with an upward pointing arrow) must not be used for editing or any other purpose.

To avoid accidental use of this key, the key cap must be removed and the switch contacts fixed in the open position with electrical tape or other insulating material.

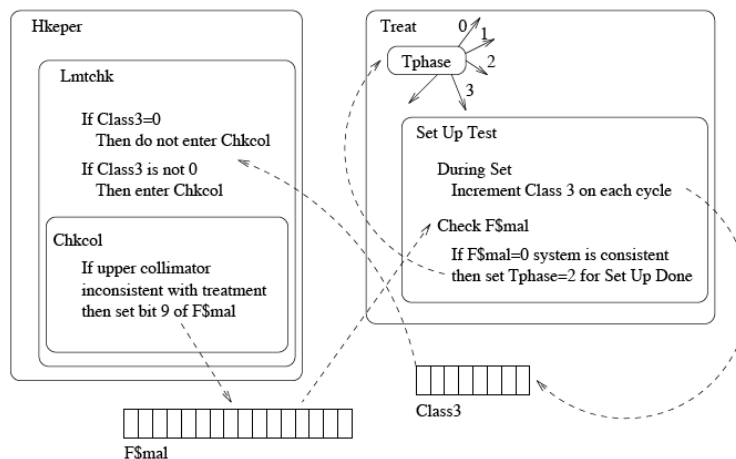
Figure 4: The Yakima software flaw.

The Race Condition

During machine setup, Set-Up Test will be executed several hundred times since it reschedules itself waiting for other events to occur. In the code, the Class3 variable is incremented by one in each pass through Set-Up Test. Since the Class3 variable is 1 byte, it can only contain a maximum value of 255 decimal. Thus, on every 256th pass through the Set-Up Test code, the variable overflows and has a zero value. That means that on every 256th pass through Set-Up Test, the upper collimator will not be checked and an upper collimator fault will not be detected.

The overexposure occurred when the operator hit the "set" button at the precise moment that Class3 rolled over to zero. Thus Chkcol was not executed, and F\$mal was not set to indicate the upper collimator was still in field-light position. The software turned on the full 25 MeV without the target in place and without scanning. A highly concentrated electron beam resulted, which was scattered and deflected by the stainless steel mirror that was in the path.

- Numerous hardware and software changes
- All interruptions related to dosimetry not continuable
- independent hardware & software shutdowns
- potentiometer on turntable
- hardware interlocks
- “dead man switch” motion enable
- Fix documentation, messages, & user manuals
- etc

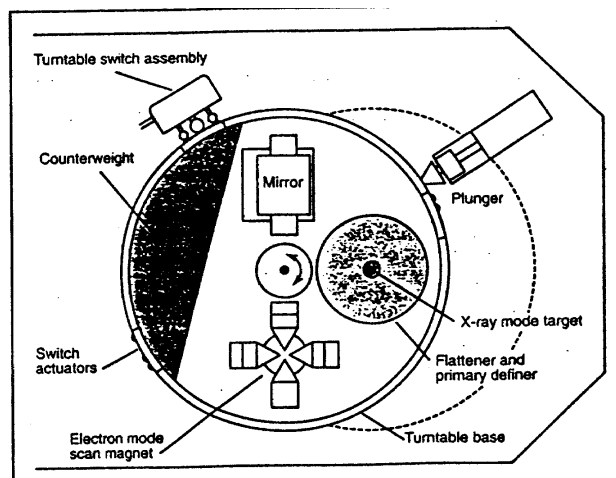
Figure B. Upper turntable assembly.

- After another machine pause, operator reentered room.
- Patient complained of burning sensation
- Patient developed severe striped burns
- Patient died in April
- Hospital obtained similar pattern on film by running machine with turntable in field light position
