## The Therac 25

A case study in safety failure

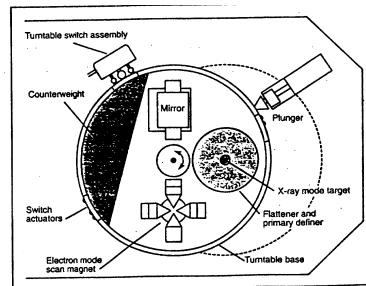
Figure B. Upper turntable assembly.

- Electron mode
  - 5-25 MEV
  - Magnets spread beam
  - Ion chamber monitor
- X-ray mode
  - 25 MEV electrons hit target
  - “Beam flattener” attenuates
  - 100x beam current
  - Ion chamber monitor
- Field-light mode
  - No current
  - Mirror & light used to check alignment
  - No ion chamber (since not treating)

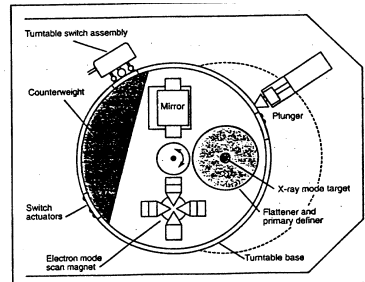
Figure B. Upper turntable assembly.

- Computer adjusts turntable position
- Microswitches detect turntable setting
- 3-bit binary code used to encode turntable setting
- Software checks replace hardware interlocks
